OLM Headlight & Tail Light Condensation Guide

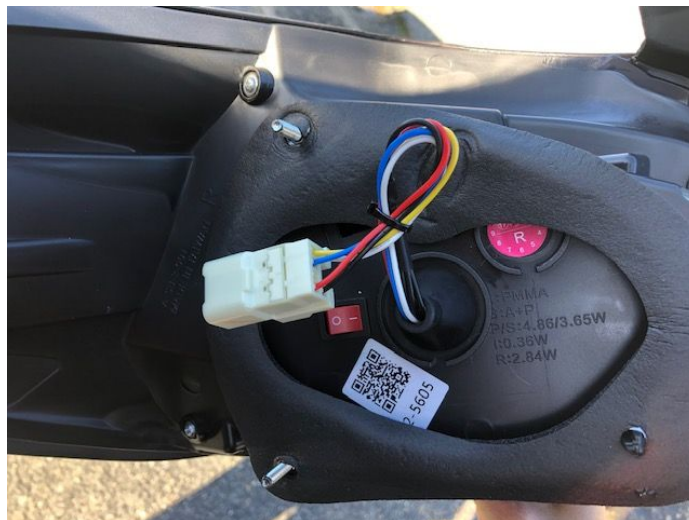
In this picture you can see the wiring bundle was stuck under the gasket which caused an indent and opening for moisture. Be sure to remove the zip tie holding the wiring bundle so it can be clear of the gasket. Depending on model, yours may not have this zip tie.
